Soil Remediation Project

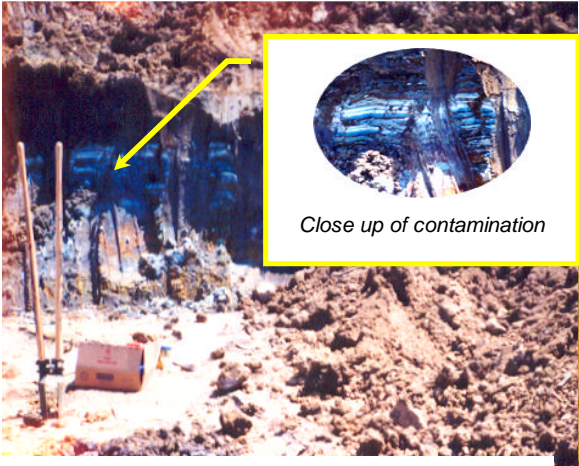
The photograph to the left shows an area where metal hydroxide sludge was encountered during the strip-mining activities.

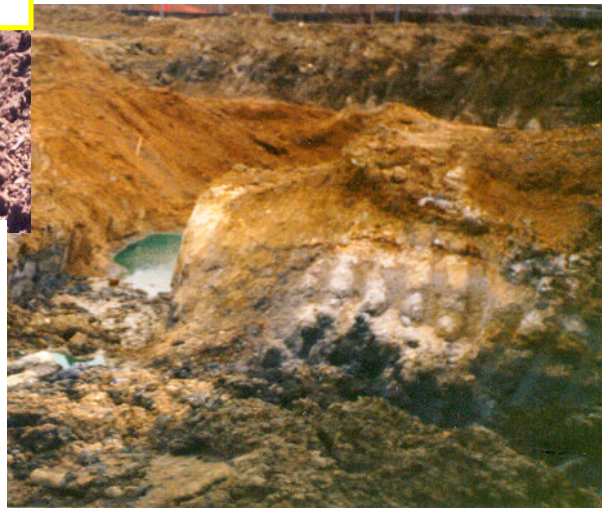
The photograph to the right shows a part of the site that contained buried process tanks. This part of the site was the major source of ground water contamination.

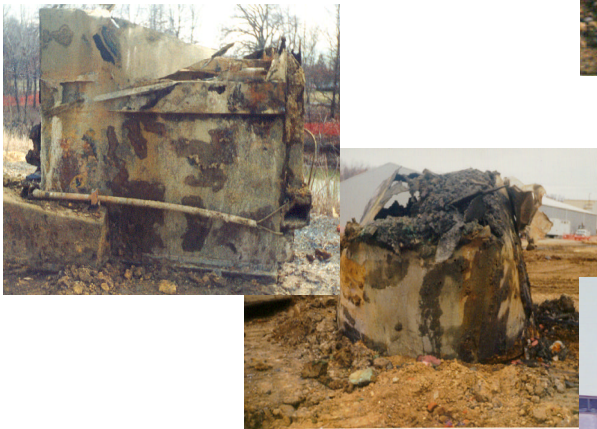
Process equipment containing plating solution and sludge is shown to the left. The equipment was removed from the excavation shown above.

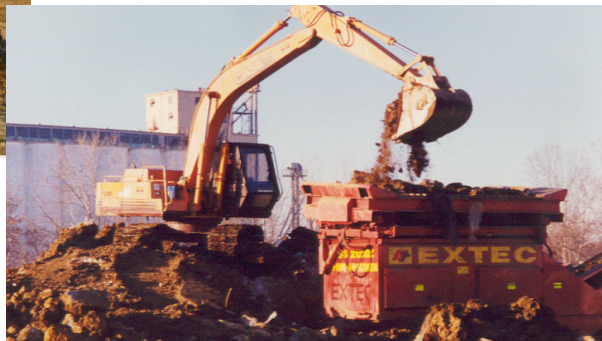
Soil excavated from the strip-mining operation was screened using an Extec screener. Acceptable material was reused onsite as backfill.
